**Intercontinental Terminals Company (ITC) Fire Update
Deer Park, Texas
April 17, 2019 0000 – April 17, 2019 1159**

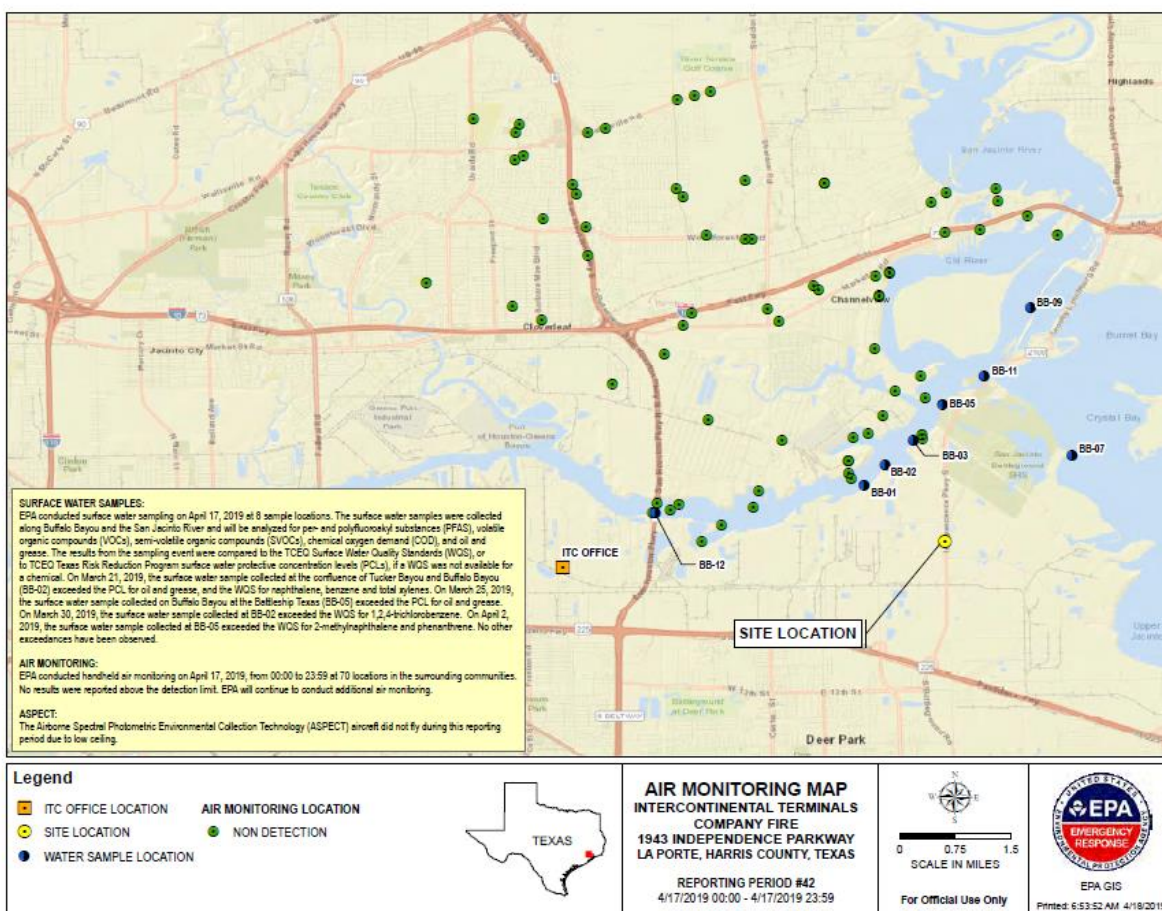
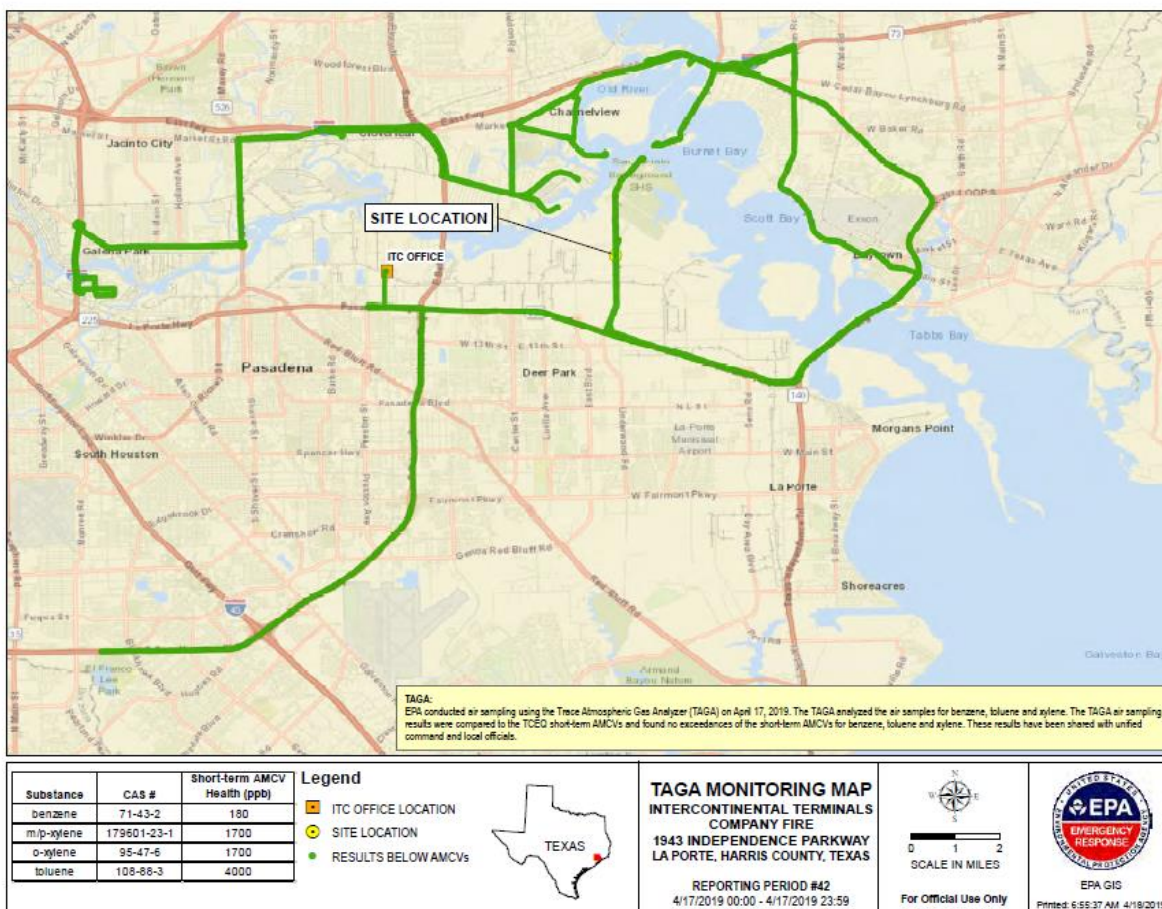
Additional Information: Air Monitoring and Water Sampling locations

- On April 17, 2019, ITC continued flushing of Tucker Bayou.
- On April 17, 2019, ITC continued material recovery from two manholes at the dock at San Jacinto Port using vacuum trucks. Both manholes will be monitored, and vacuum truck operations will continue as needed on April 18, 2019.
- EPA conducted surface water sampling on April 17, 2019 at 8 sample locations. The surface water samples were collected along Buffalo Bayou and the San Jacinto River and will be analyzed for per- and polyfluoroalkyl substances (PFAS), volatile organic compounds (VOCs), semi-volatile organic compounds (SVOCs), chemical oxygen

demand (COD), and oil & grease. The results from the sampling event were compared to the TCEQ Surface Water Quality Standards (WQS), or to TCEQ Texas Risk Reduction Program surface water protective concentration levels (PCLs), if a WQS was not available for a chemical. On March 21, 2019, the surface water sample collected at the confluence of Tucker Bayou and Buffalo Bayou (BB-02) exceeded the PCL for oil and grease, and the WQS for naphthalene, benzene and total xylenes. On March 25, 2019, the surface water sample collected on Buffalo Bayou at the Battleship Texas (BB-05) exceeded the PCL for oil and grease. On March 30, 2019, the surface water sample collected at BB-02 exceeded the WQS for 1,2,4-trichlorobenzene. On April 2, 2019, the surface water sample collected at BB-05 exceeded the WQS for 2-methylnaphthalene and phenanthrene. No other exceedances have been observed.

- Several entities including TCEQ, EPA, and ITC continue to conduct air monitoring around the tank farm, in adjoining industrial areas, and communities downwind from the facility.

- EPA conducted handheld air monitoring on April 17, 2019, from 00:00 to 23:59 at 70 locations in the surrounding communities. No results were reported above the detection limit. EPA will continue to conduct additional air.

- The Airborne Spectral Photometric Environmental Collection Technology (ASPECT) aircraft did not fly during this reporting period due to low ceiling.
- EPA conducted air sampling using the Trace Atmospheric Gas Analyzer (TAGA) on April 17, 2019. The TAGA analyzed the air samples for benzene, toluene and xylene. The TAGA air sampling results were compared to the TCEQ short-term AMCVs and found no exceedances of the short-term AMCVs for benzene, toluene and xylene. These results have been shared with unified command and local.
